Optis[®] E-line Job Report

Company : Petronas Carigali Sdn Bhd
Field : KNNAG
Well : KNJT-C4
Country : Malaysia
Date Recorded: 30/12/2023
Date Issued : 01/11/2023
Reference : **16381**

Dimension Bid has carried out a downhole video log in KNJT-C4 with the objective to identify the condition of EGF Flapper. The flapper is suspected to be in partially close condition.

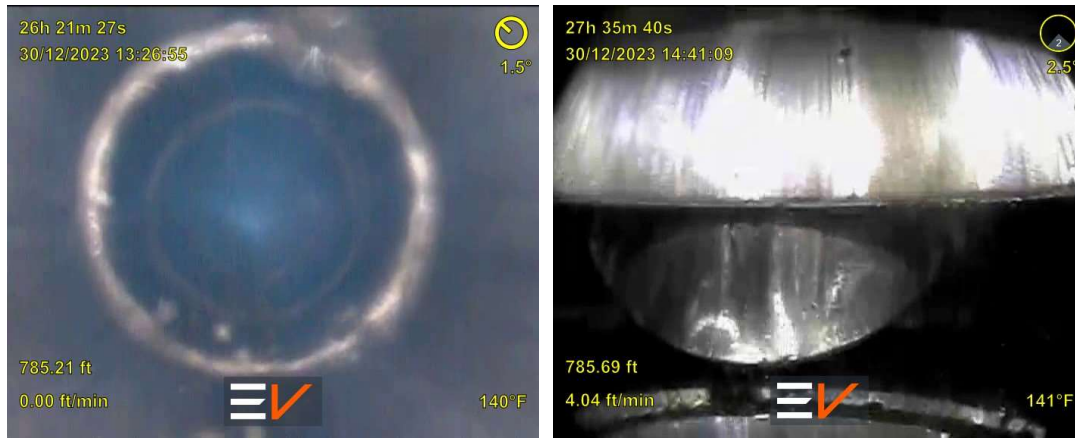
Video acquired shows that there is no obstruction of the suspected EGF flapper. Below is image of the flapper at 786 ftTHF.

Fig.1.1 EGF Flapper condition at 786 ft

Video footage shows that there is no obstruction from the EGF Flapper that suspected to be in partially close condition.

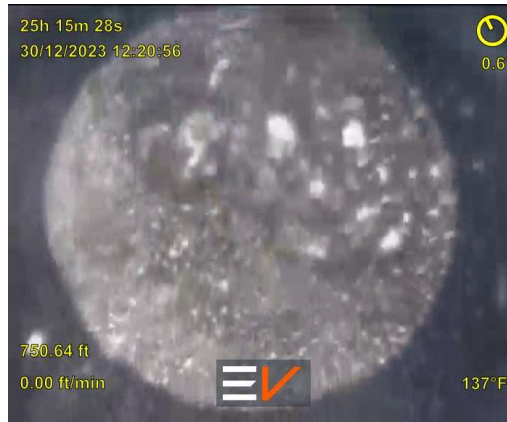
Throughout the camera run, communication from tool was fine and check regularly for DV and SV angle until reaching at TRSV at 786 ft, thou during RIH while pumping the visibility is unclear due

water displacement downhole. Water is then stop pumped at 750ft and waiting for the fluid level to further to lower down until below TRSV.

Fig.3.1 DV Cam at 750ft observe fluid slowly displaced downhole.

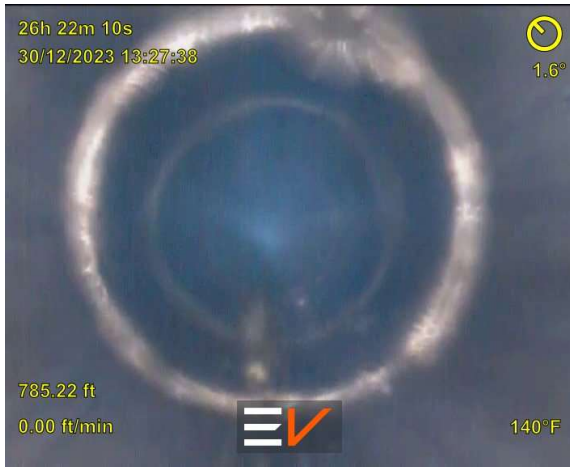
DV at 785ft

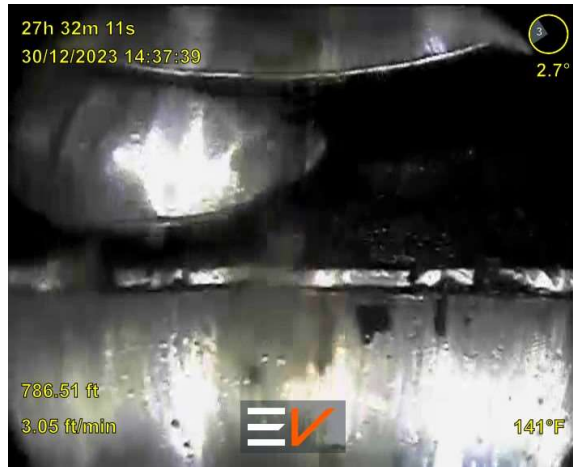
Toolstring reached at TRSV 786ft (flapper) and the camera gave a good result during the process. There is no obstacle to the expected EGF Flapper depth of 786 ft only visualise that the flowtube is not fully travel. WSS then agreed to POOH, and the video of accessories was taken from 787ft - 783ft.

SV at 786ft flapper

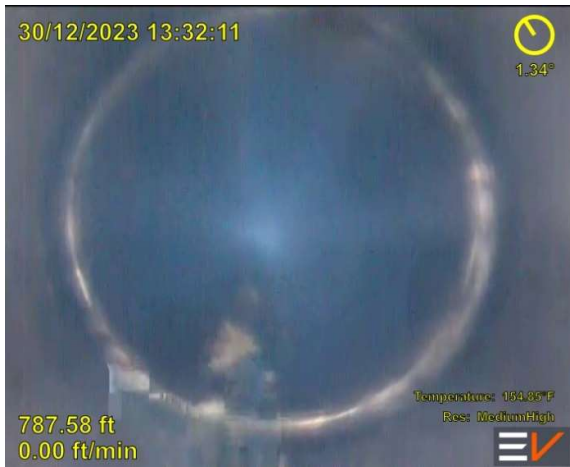
DV at 787ft

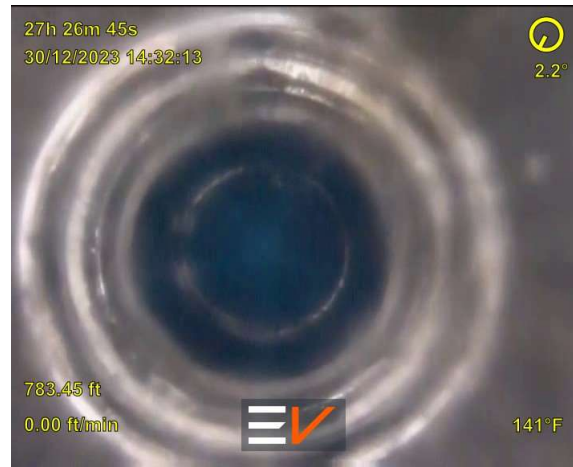
DV at 783ft
