PROBLEM REPORT

(B)	Problem Title: Crossover miss out mobilization to Angsi Bravo for Well B15			PR Running No:
(C)	Equipment/ Tool Involved (Serial/ Part No.) Wellhead Crossover (7-5 x CB44 and CB44 X CB22)			
	Supplier:

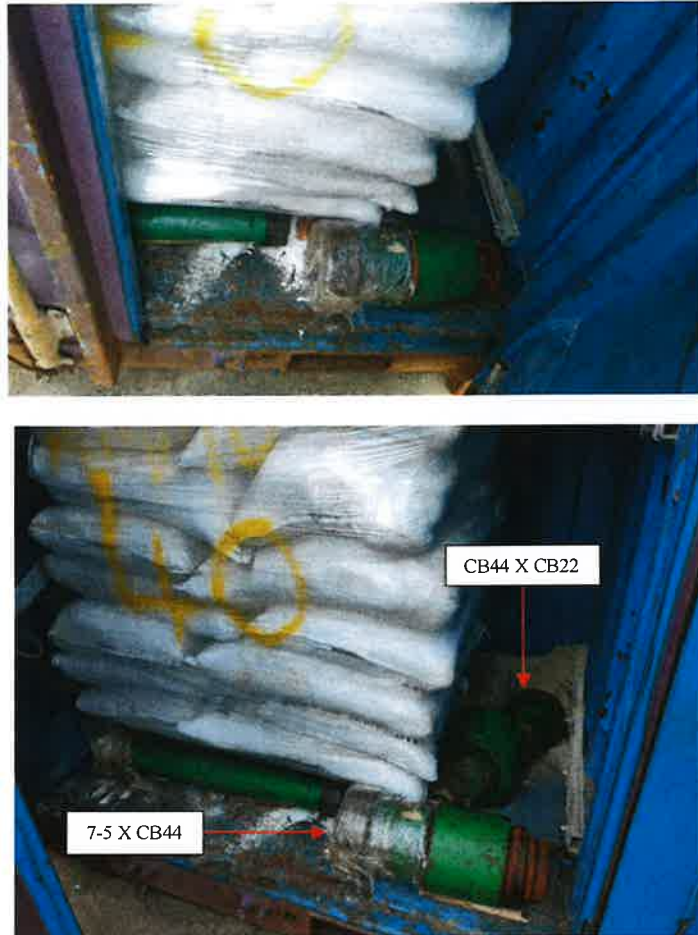
Figure 1: 7-5 X CB44 and CB44 X CB22 Crossover Packed in Cargo Container MM6-1002

Finally, on **August 6, 2024**, the crew prepared for the loadout for well B15. Unfortunately, the crossover that was initially prepared for B15 was inside chemical container for B22 loadout. Due to congested space on the main deck area, the B22 equipment was left out from the loadout. This oversight led to the crucial error of excluding the wellhead crossover required for well B15.

(F)	<p><u>Recommendation and Solution</u></p> <ol style="list-style-type: none"> 1. Development of New Documentation for Equipment Requests (Iron Request): A new, standardized document will be created specifically for equipment requests. This "Iron Request" form will clearly outline the equipment required for each well, ensuring that all necessary items are accounted for and reducing the risk of oversight. 2. Enhancement of the Load-Out List (LOL): The existing Load-Out List will be improved by adding a new column to specify the well number associated with each basket and container. This enhancement will allow for more precise tracking and segregation of equipment, ensuring that items are correctly allocated to their intended destinations. 3. Improvement of Labelling Procedures: The labeling process will be enhanced by logistics to include clear identification of the well number on each basket and container. This will involve updating labeling stickers to ensure that they prominently display the well number, facilitating easier identification and reducing the likelihood of equipment being packed incorrectly.
