POST JOB REVIEW

TEMANA TANGO SAND CLEAN-OUT

TEMANA T-77S

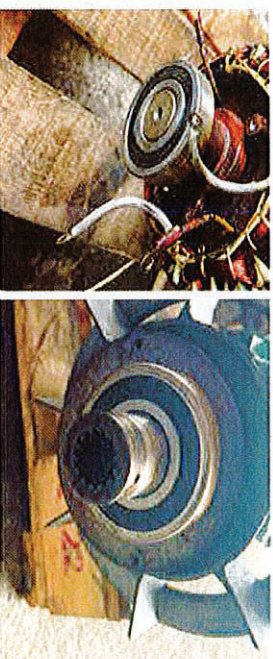
Finding:

DE & NDE bearing worn out

Recovery Action:

Replaced with new bearings.

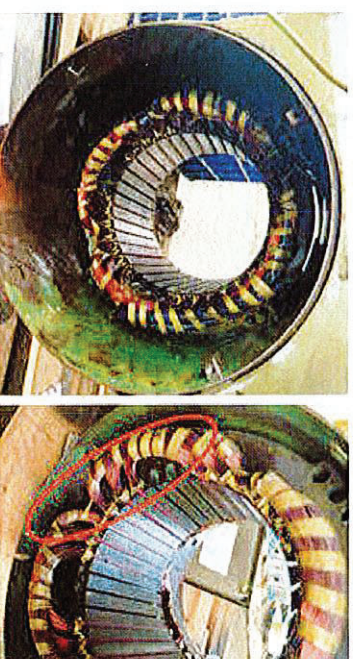
Finding:

Main Stator Winding
overheated phase 1

Recovery Action:

Rewinding new main stator
winding

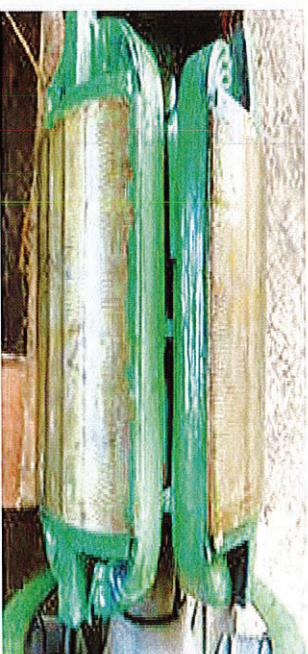
Finding:

Main field rotor IR low

Recovery Action:

Wash, dip varnish and oven baking winding

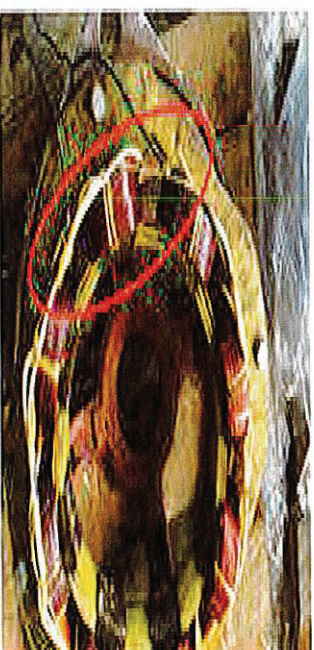
Finding:

Exciter Stator winding overheated

Recovery Action:

Rewinding new exciter stator winding
