Title	Catastrophic, Major & Serious (CMS) Accidents / Incidents Investigation and Analysis			
Target Population	Field Engineers & Field Specialists			
This requirement is applicable to:	✓	JFE	FST	EOT
	✓	FE1	FS1	EO1
	✓	FE2	✓ FS2	EO2
			✓ FS3	EO3

(B)	<u>Problem Title:</u> Crossover miss out mobilization to Angsi Bravo for Well B15		<u>PR Running No:</u>	
(C)	<u>Equipment/ Tool Involved (Serial/ Part No.)</u> Wellhead Crossover (7-5 x CB44 and CB44 X CB22)			
<i>Supplier:</i>

Problem Statement:	Wellhead crossover missed out mobilization to Angsi B for well B15
PR Running No.:	PR2024-CTS-AUG-057
Date of Investigation:	18 th August, 2024
Date of Investigation (Closed):	20 th August, 2024

Improving Mobilization Efficiency: Addressing Equipment Oversights Through a Standardized Tracking System

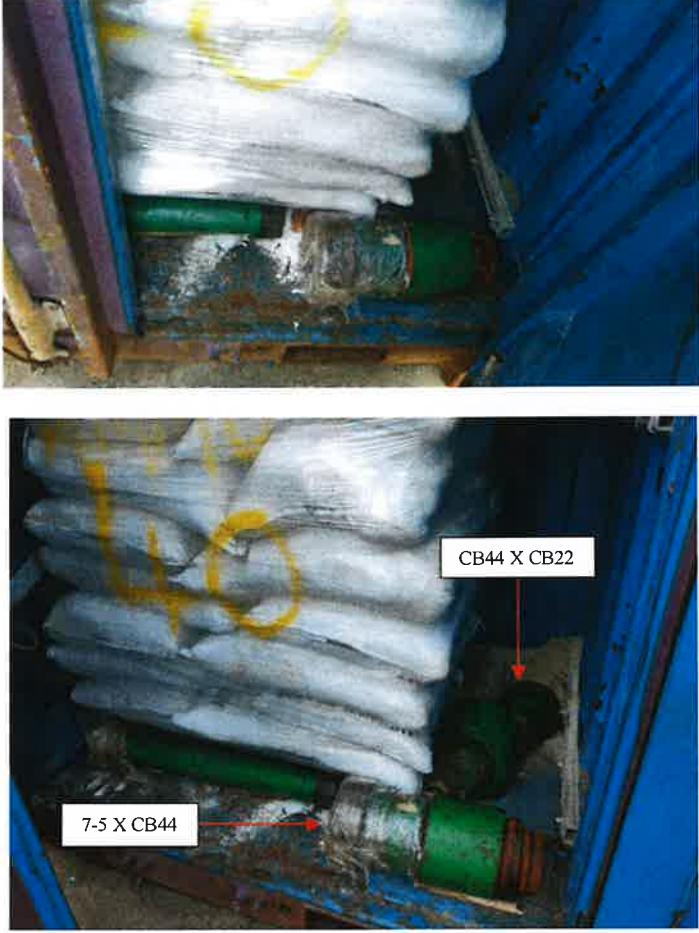
<p>Figure 1: 7-5 X CB44 and CB44 X CB22 Crossover Packed in Cargo Container MM6-1002</p> <p>However, on July 9, 2024, a sudden change in operational plans occurred. The focus shifted from wells B15 and B22 to well B18L, which required different preparations, including the mobilization of an N2 package. Consequently, the List of Loadouts (LOL) for B18L was submitted, and the loadout equipment for wells B15 and B22 was put on hold.</p> <p>By July 16, 2024, the loadout for well B18L was successfully completed. However, due to changes in plan, the wellhead crossover, which was initially planned for well B15 was excluded from this loadout.</p> <p>Finally, on August 6, 2024, the crew prepared for the loadout for well B15. Unfortunately, the crossover that was initially prepared for B15 was inside chemical container for B22 loadout. Due to congested space on the main deck area, the B22 equipment was left out from the loadout. This oversight led to the crucial error of excluding the wellhead crossover required for well B15.</p> <p>Note: Please describe 1. <u>Chronology that leads to incident</u>, 2. <u>Your observation/evidence on current situation</u> 3. <u>Client Feedback</u> and 4. <u>Evidences found and preservation action taken</u> <u>Preserve all evidence for problem identification/reproduction at base.</u></p>

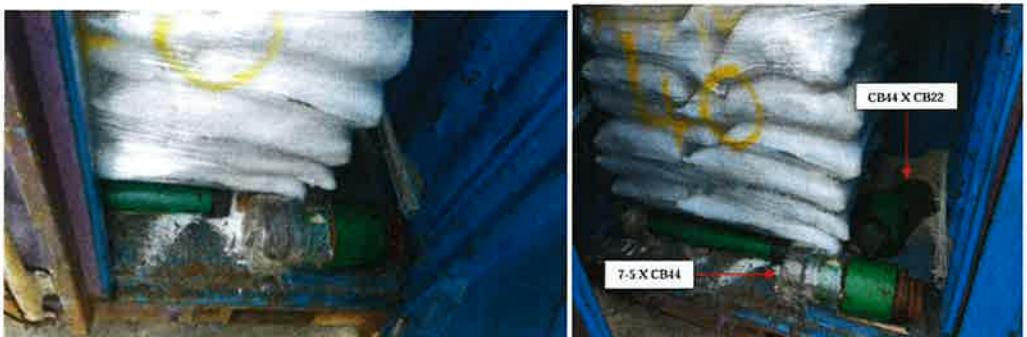
<p>Figure 1: 7-5 X CB44 and CB44 X CB22 Crossover Packed in Cargo Container MM6-1002</p>

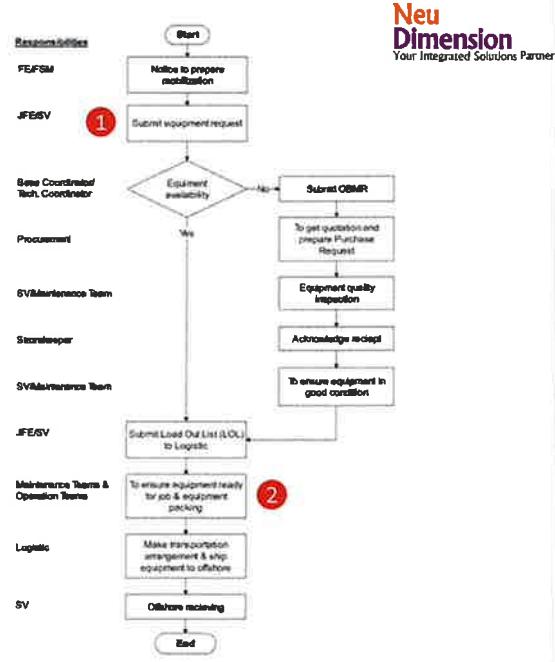
- Critical equipment being overlooked during the packing process, leading to instances where baskets are mobilized without all necessary items
- Based on discussions between management regarding the load-out system, the identified gaps in the process are as follows:
 1. **Currently, equipment requests are limited to Bottom Hole Assembly (BHA) and chemicals, with no formal process in place for requesting critical equipment.** This omission results in incomplete information transfer, increasing the likelihood of errors.
 2. **There is no package preparation report to confirm that the equipment is ready for mobilization.** The absence of this report can lead to human error and oversight during the packing and mobilization process."

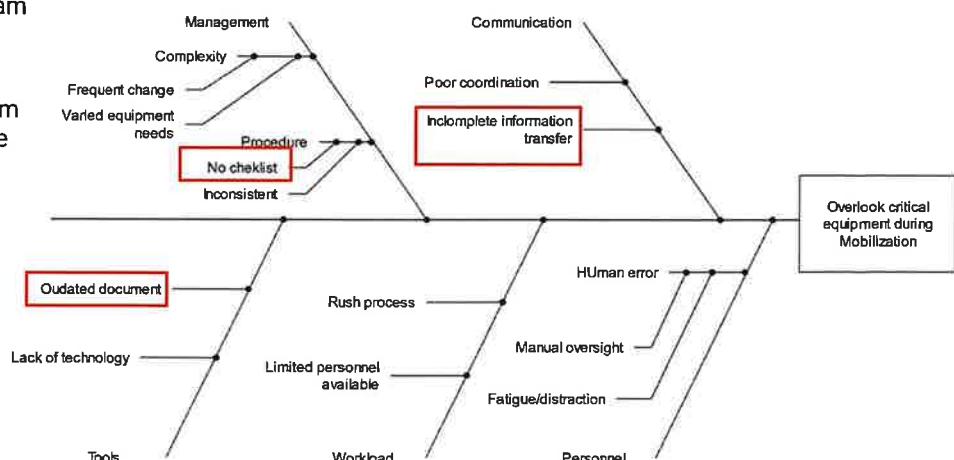
- Possible causal factors by Fish Bone/Ishikawa Diagram
 - The possible causes were jot down and through out the system mobilization, there are 3 main cause for the problem

- **Poor Coordination:** Lack of clear communication between departments or team members about what equipment needs to be included in each mobilization.
- **Incomplete Information Transfer:** Critical information about required equipment may not be passed along properly from planning to execution stages.

- **Manual Oversight:** Relying on memory or manual tracking increases the likelihood of human error, leading to missed items.
- **Fatigue or Distraction:** Workers might miss items due to fatigue, distraction, or being rushed during the packing process.

- **Lack of Technology:** The absence of digital tools or software to track and manage equipment lists can lead to items being overlooked.
- **Outdated Document:** Existing documentation might be outdated or incomplete, leading to items not being included in the packing process.

- **Rushed Processes:** Tight deadlines or heavy workloads may force teams to rush through the packing process, increasing the risk of missing equipment.
- **Insufficient personnel available:** Limited personnel available for packing and checking equipment can lead to oversights.

- **Varied Equipment Needs:** Projects that require different sets of equipment can make it difficult to track what is needed for each mobilization, especially without a clear system.
- **Frequent Changes:** Changes to equipment requirements that are not promptly updated in tracking documents can result in missing items.
- **Inconsistent Processes:** Different teams or individuals may follow varied procedures for packing, leading to inconsistencies in what is considered "complete."
- **No Checklist:** Absence of a standardized checklist or protocol for ensuring all equipment is accounted for before mobilization.

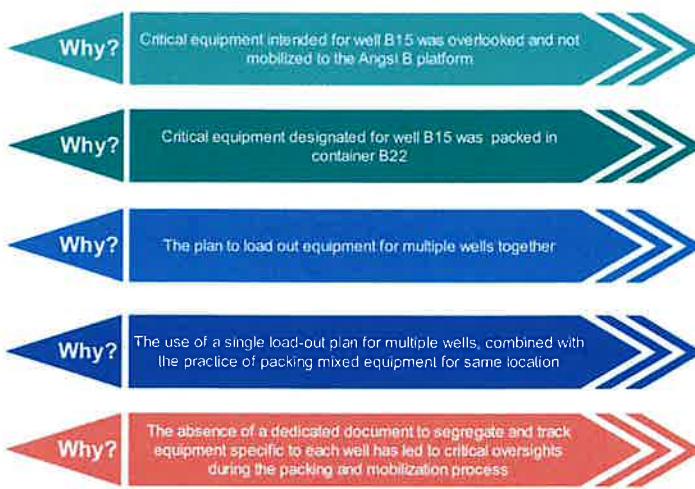
➤ Root cause of the problem after using elimination method using 5 WHY

➤ The three primary causal factors for this problem were analyzed using the 5 WHY method, which led to the identification of the root cause. The root cause was determined to be the lack of documentation to track the packing of critical equipment prior to load-out.

To address the identified issues and prevent future occurrences, the following steps will be implemented:

To improve operational efficiency, the Treating Iron Movement Activity will be upgraded to include requests for critical equipment such as iron, crossovers, and other essential components. The new 'Crossover Request' form will clearly specify the equipment required for each well, ensuring comprehensive accountability and minimizing the risk of oversight.

The existing Load-Out List will be improved by adding a new column to specify the well number associated with each basket and container. This enhancement will allow for more precise tracking and segregation of equipment, ensuring that items are correctly allocated to their intended destinations.

To address the crossover issue and ensure all necessary resources are properly allocated, the Project Engineer will develop a 7-14 day operational lookahead for campaign mode. This lookahead will serve as a proactive planning tool, capturing and scheduling all required elements, including personnel, equipment, chemicals, and boat schedules. By systematically identifying and planning for these needs well in advance, the lookahead will help to ensure that critical items, such as crossovers and other equipment, are not overlooked, thereby improving overall operational readiness and efficiency.
