# POST JOB REVIEW

## TEMBUNGO BRAVO

# TEMBUNG BRAVO PRE P&A MIT CAMPAIGN

- The proposed work scope for TBG-BRAVO is to perform MIT logging using MIT24F to inspect the tubing internal condition and integrity by analysing any corrosion, erosion or physical damage prior to Plug and Abandonment.

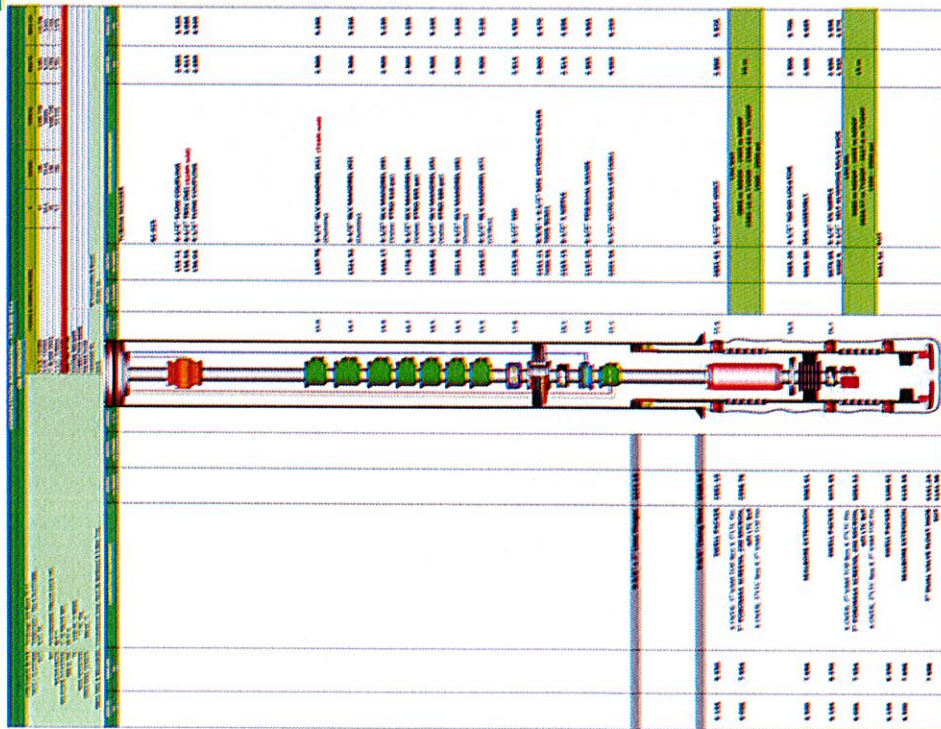
# BACKGROUND (B-05)

## WELL INFO

| WELL | B-05ST1 |
| TUBING SIZE | 3-1/2" 9.2 L80 JFE-FOX |
| CASING SIZE | 9-5/8" 47 L80 VAM TOP |
| MIN ID | 2.690" XN NIPPLE @ 10008 ftMDTHF |
| MAX DEVIATION | 77.36 DEG 9482 ftMDTHF |
