Optis® E-line Job Report

Company : Petronas Carigali Sdn Bhd
Field : KNNAG
Well : KNJT-C4
Country : Malaysia
Date Recorded: 30/12/2023
Date Issued : 01/11/2023
Reference : **16381**

Dimension Bid has carried out a downhole video log in KNJT-C4 with the objective to identify the condition of EGF Flapper. The flapper is suspected to be in partially close condition.

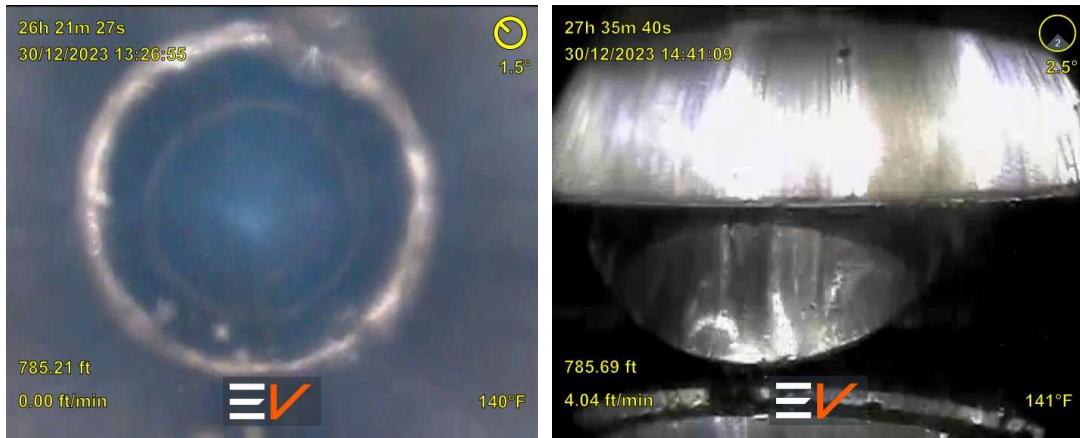
Fig.1.1 EGF Flapper condition at 786 ft

Video acquired shows that there is no obstruction of the suspected EGF flapper. Below is image of the flapper at 786 ftTHF.

Video footage shows that there is no obstruction from the EGF Flapper that suspected to be in partially close condition.

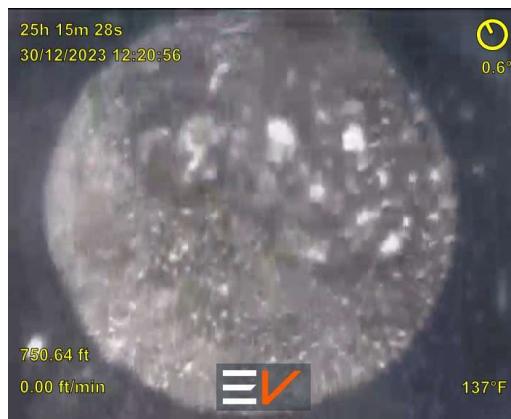
Fig.3.1 DV Cam at 750ft observe fluid slowly displaced downhole.

water displacement downhole. Water is then stop pumped at 750ft and waiting for the fluid level to further to lower down until below TRSV.

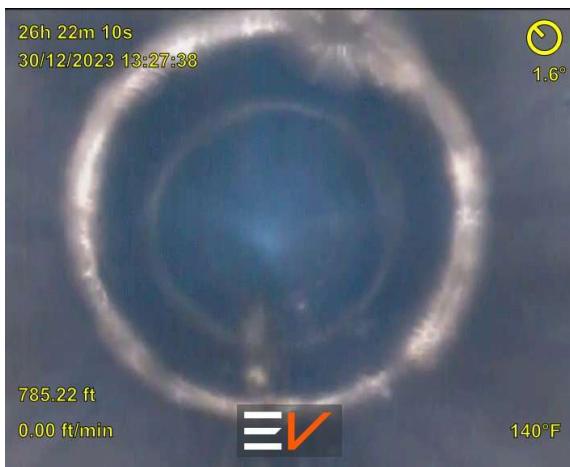
DV at 785ft

Toolstring reached at TRSV 786ft (flapper) and the camera gave a good result during the process. There is no obstacle to the expected EGF Flapper depth of 786 ft only visualise that the flowtube is not fully travel. WSS then agreed to POOH, and the video of accessories was taken from 787ft - 783ft.

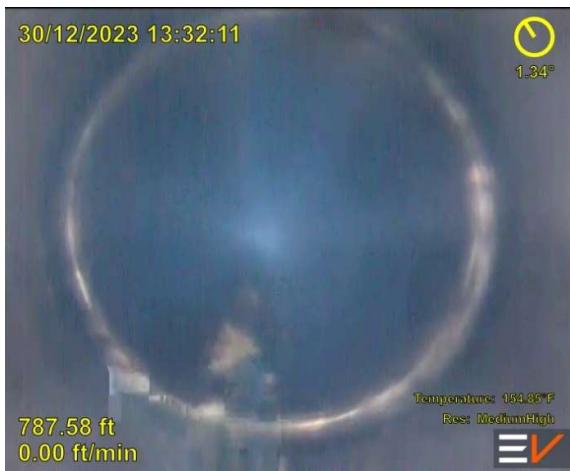
DV at 787ft

The deepest depth of the camera survey is 787 ft (DV). No anomaly was found during log down to 787 ft.

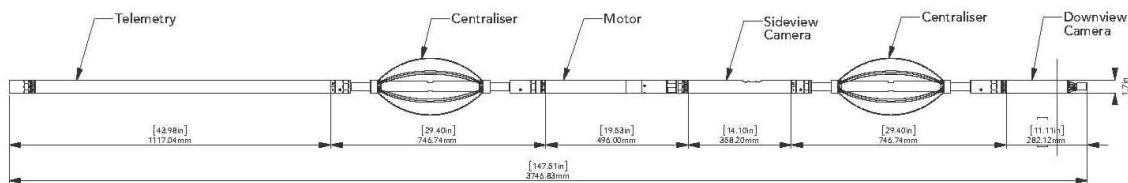
Diameter	1.7 in	43.0 mm
Length*	147.5 in	3746.8 mm
Pressure rating	15,000 psi	1034 bar
Temperature rating	257 °F	125 °C
Camera Type	Downview (Colour) & 360° Motorised Sideview (Colour)	
Video Frame Rate	Up to 25 fps	
Recording Capacity	Continuous real-time transmission to surface
