END OF JOB REPORT

PCSB SBA

KNNAG KNJT-C: WELL C01

To perform RMX Contact Logging on well KNJT-C C01.
(Depth 11375-14025 ft.MDDF)

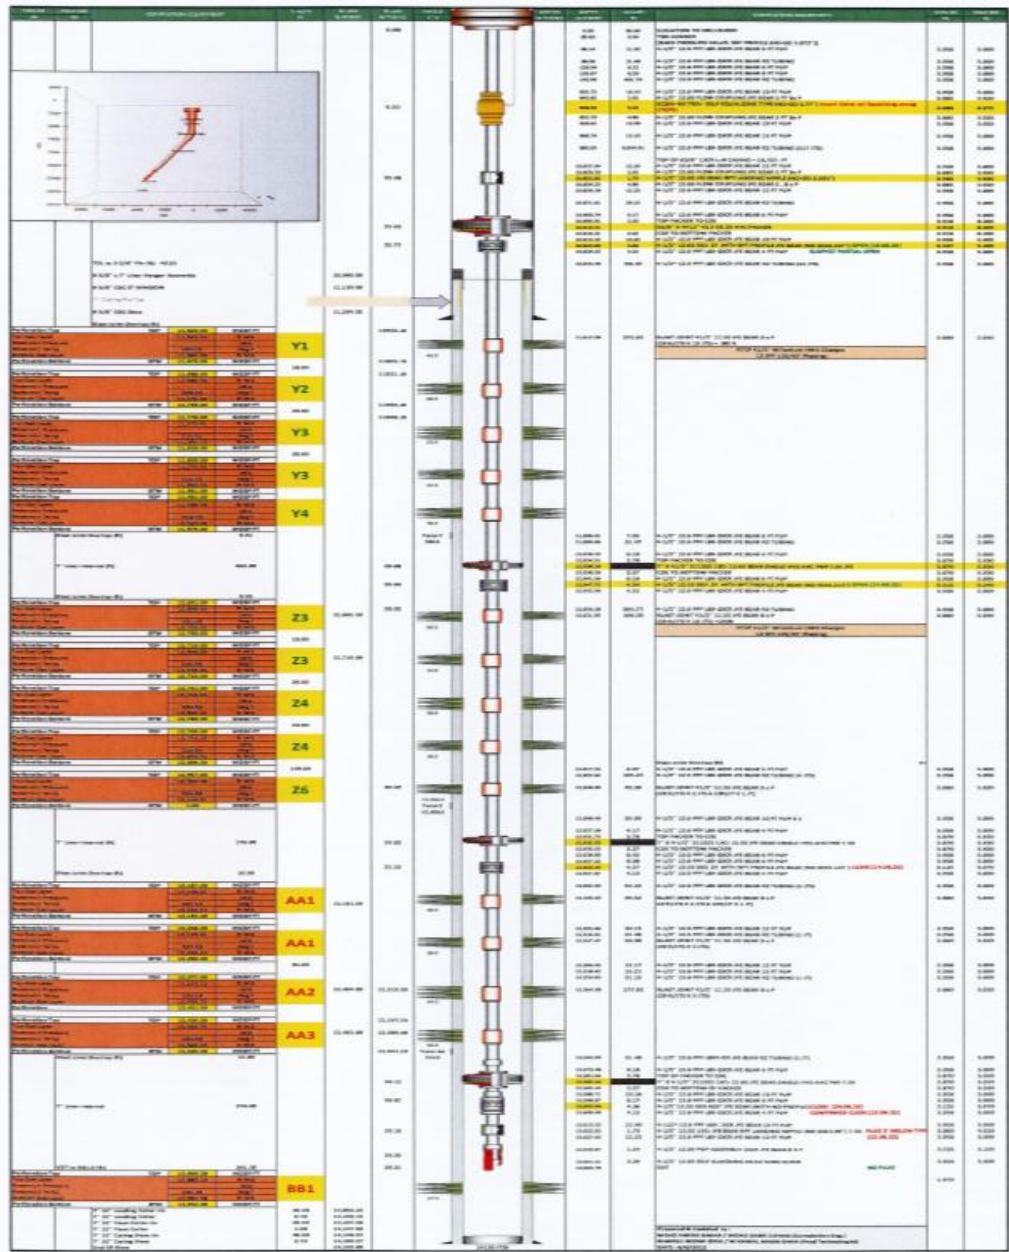
BACKGROUND (KNJT-C C01)

WELL	KNAG-C001201-TS
TUBING SIZE	4-1/2", 12.6PPF, L-80
CASING SIZE	9-5/8"
MIN ID	3.0" at No-Go @ 13,625.92 ft-MDDF
MAX DEVIATION	30.31 Degree

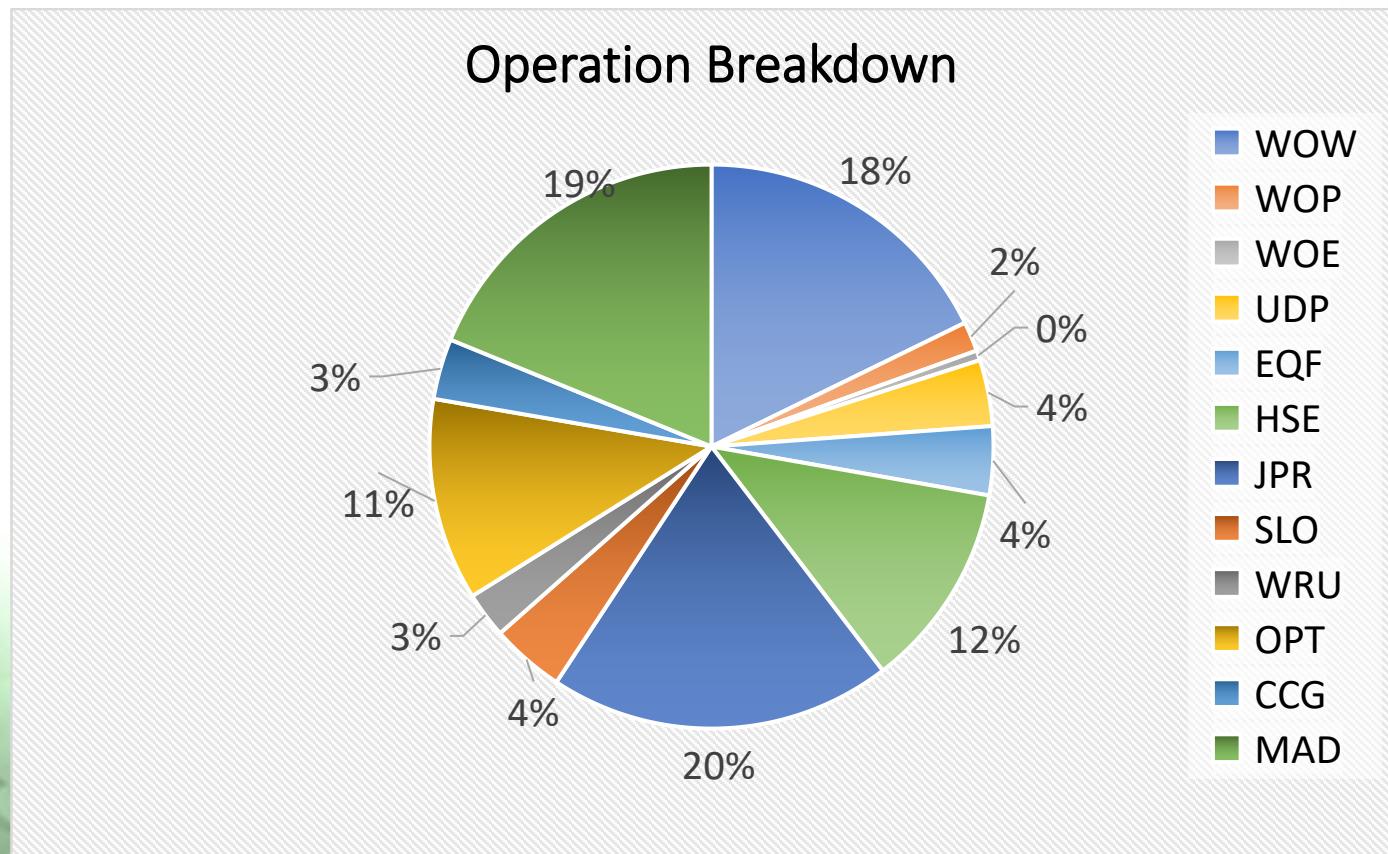
WOW	WOP	WOE	UDP	EQF	HSE	JPR	SLO	WRU	OPT	CCG	MAD	TOTAL
TOTAL DAYS	125.3	12.0	4.0	26.8	27.8	83.4	138.5	29.8	18.5	81.8	24.5	132.6	
	195.8												509.0
50		Non-Productive Time											Productive Time
		27.78%											72.22%
													704.8
