Title	End of Well Report and Service Quality Meeting (SQM)			
Target Population	Field Engineers & Field Specialist			
This requirement is applicable to:	✓	JFE	FST	EOT
	✓	FE1	FS1	EO1
	✓	FE2	FS2	EO2
		✓	FS3	EO3

SERVICE QUALITY MEETING (SQM)

PETRONAS CARIGALI
	ANGSI B-02L	EOWR

Bekok C-17	EOWR

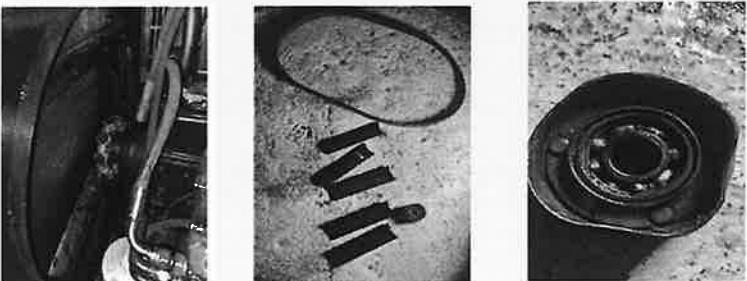
Figure 1 : Leak radiator

Figure 2 : Parted fan blade

No	Problem Title (brief description)	Gap Identified (Root Cause)	Way Forward (Long Term Solution)
2	Mini Pump Broken Fan and Radiator Leaking 21 th October 2023, @Dulang-Charlie At 0300 hrs during midnight, night shift crew were perform start up the engine of mini pump prior to warming up engine/running test. Suddenly the fan/blade touching radiator then the fan/blade broken, affected radiator leakage which is suspected the pulley tensioner bearing problem that cause belt tensioner loose and disclosed.	Wear & Tear: Damaged tensioner pulley bearing. Tensioner pulley bearing can be damaged by several reason such as lack of greasing, improper maintenance, long term usage without replacement and wear and tear.	<ol style="list-style-type: none"> 1. To remind crew in consistently practice on check condition of tensioner pulley bearing during EMC 1, EMC 2 and during pre-mob briefing. 2. To remind crew always apply grease on tensioner pulley bearing during EMC 1, EMC 2 and during pre-mob briefing .

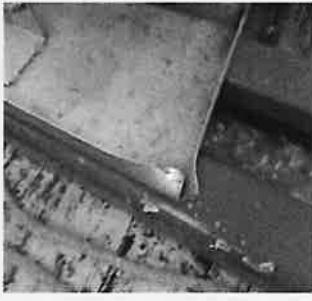
Figure 2 : Damage at pipe's drip pan observed

OPERATION – ROOT CAUSE FAILURE ANALYSIS				Neu Dimension
No	Problem Title (brief description)	Gap Identified (Root Cause)	Way Forward (Long Term Solution)	
5	Nitrogen Tank Collision 7 th June 2024, @Angsi Besar (Lifting Activity) An incident occurred involving a nitrogen tank and a boat anchor station during a lifting operation from one boat (Berkat Tenang) to another boat (Setia Ulung), resulting in a dented pipe on the nitrogen tank. The incident took place at Setia Ulung (the receiving boat). During the lifting activity, which was conducted under standard operating procedures, the nitrogen tank inadvertently collided with the anchor station on the receiving boat. The impact caused a visible dent in one of the pipes attached to the nitrogen tank. Fortunately, no injuries were reported among the crew members involved in the operation.	Unplanned development of workplace condition: Dented nitrogen tank pipe was caused by adverse weather conditions. The adverse oceanic conditions encountered during the lifting operation posed significant challenges in operational management, thereby elevating the risk of collisions.	<ul style="list-style-type: none"> To emphasize and apply the STOP WORK when there is unsafe condition during operation. Conduct safety sharing about stop work policy before performing heavy lifting during bad weather.

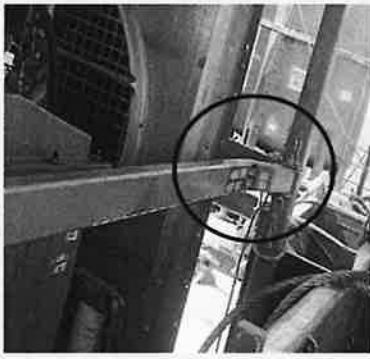
Figure 1 : Single Pump crash beam hit by basket during lifting.

OPERATION – ROOT CAUSE FAILURE ANALYSIS				Neu Dimension
No	Problem Title (brief description)	Gap Identified (Root Cause)	Way Forward (Long Term Solution)	
6	Single Pump Crash Beam Collided by Basket during Lifting 11 th June 2024, @Angsi Besar (Lifting Activity) During the lifting activity from the boat (SK Power) to the platform (BsDP-A), the crash beam of single pump unit was observed to be bent and secure pin for single pump broken. This incident occurred in high ocean current conditions, which likely contributed to the difficulty and instability of the lifting process. One of DB crew saw Cargo basket collided with the pump which be the cause of the bent during lifting activity between AWB Setia Ulung and SK Power. Pedestal Crane AWB Setia Ulung need to reposition the basket from the front of the SK power to end of SK Power due to Crane BsDP-A cannot reach that area. While Cargo basket in hanging position, observe that the Boat rolling over which cause the cargo basket collide with the Single Pump. The swaying motion of the boat led to the cargo basket colliding with the single pump.	Unplanned development of workplace condition: caused by adverse weather conditions. Bending crash beam and broken secure pin were caused by adverse weather conditions.	Conduct safety sharing about stop work policy before performing heavy lifting during bad weather

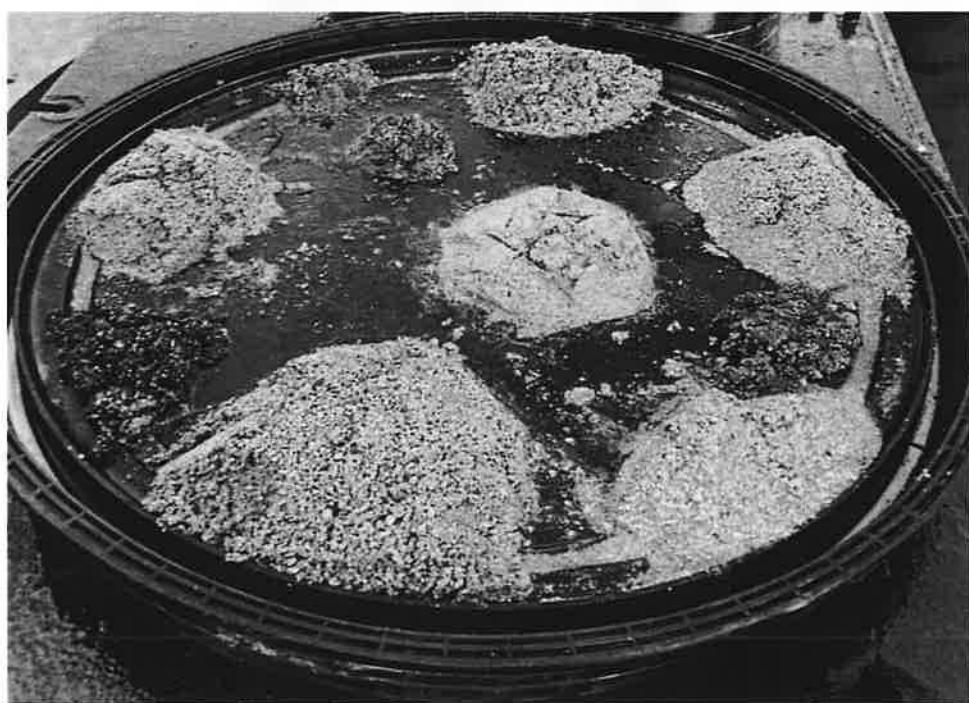
Figure 10 SAND RECOVERED FROM 3RD RUN

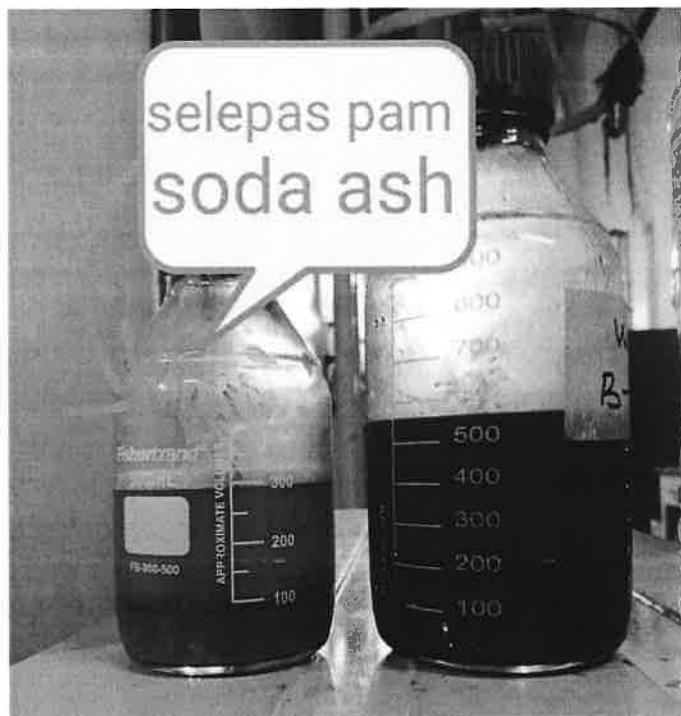
Figure 11 RETURN SAMPLE

RETURN SAMPLE
TEMPERATURE, 40 DEG C

RETURN SAMPLE
TEMPERATURE, 60 DEG C

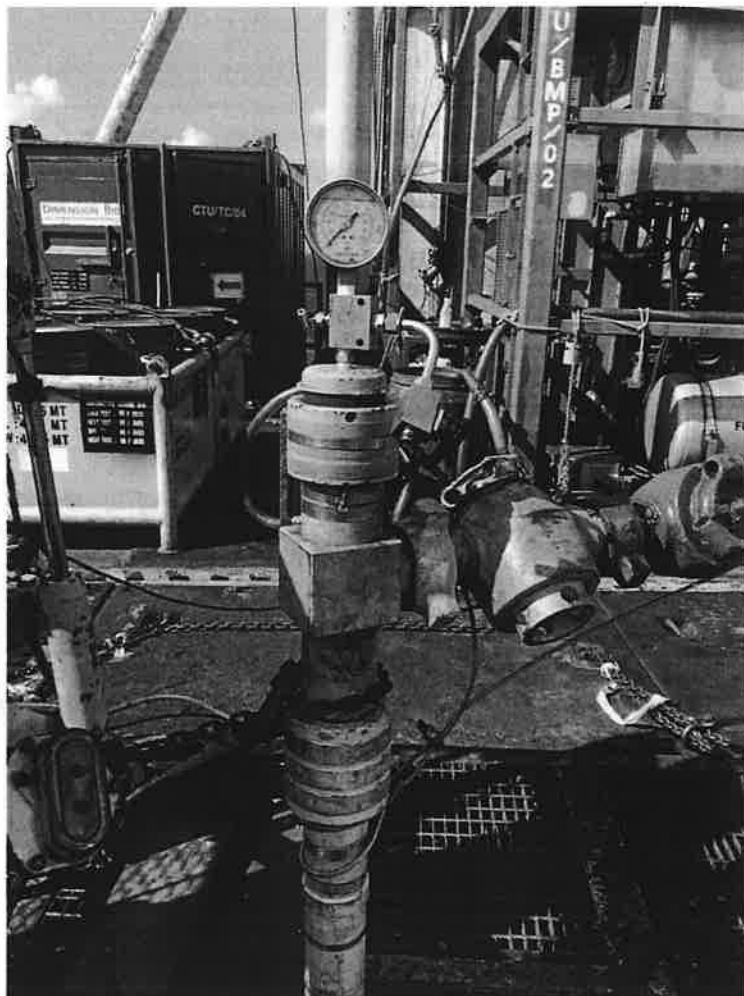
Figure 13 THP Pressure Gauge
