Optis[®] E-line Job Report

Company : Petronas Carigali Sdn Bhd
Field : KNNAG
Well : KNJT-C4
Country : Malaysia
Date Recorded: 30/12/2023
Date Issued : 01/11/2023
Reference : **16381**

Dimension Bid has carried out a downhole video log in KNJT-C4 with the objective to identify the condition of EGF Flapper. The flapper is suspected to be in partially close condition.

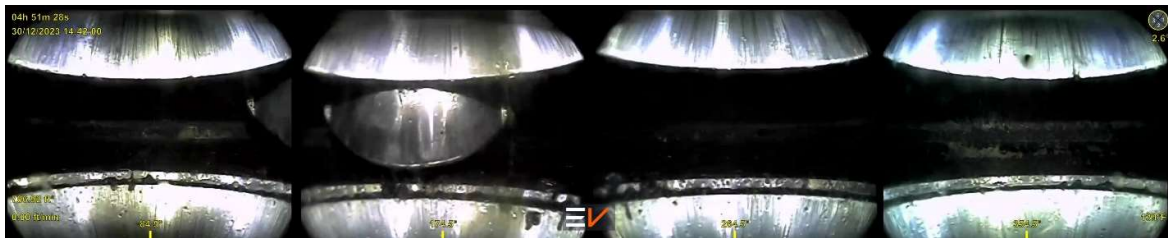
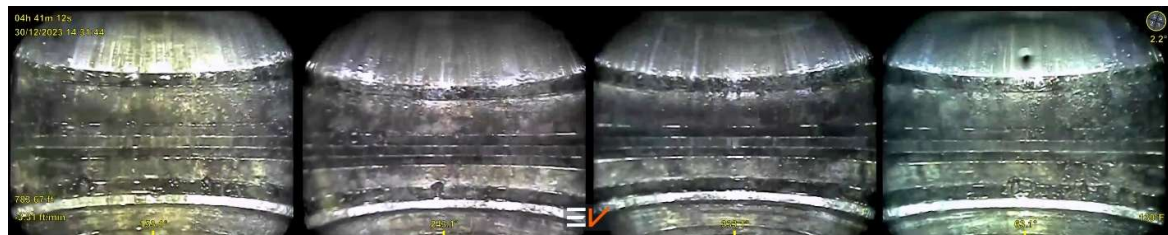
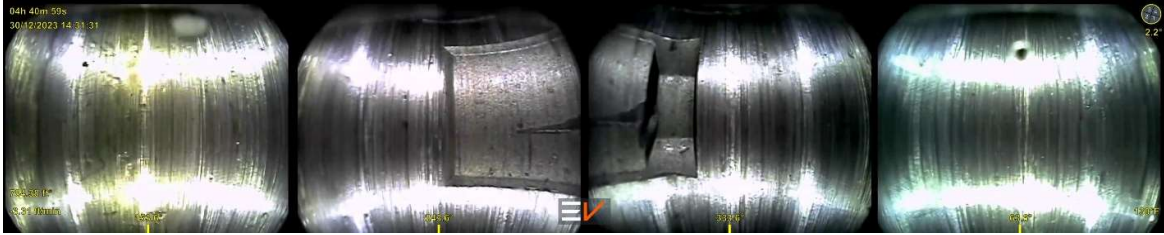
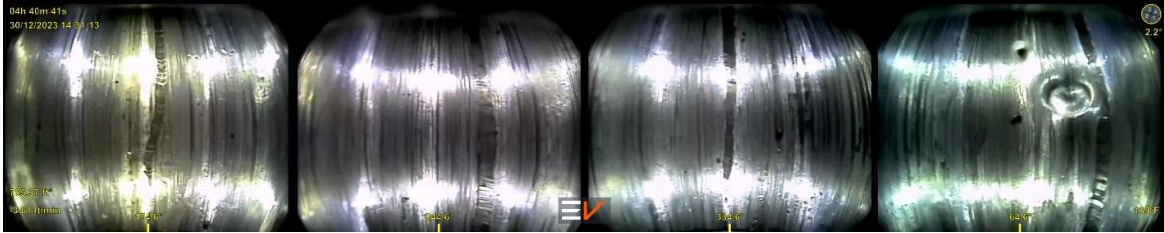
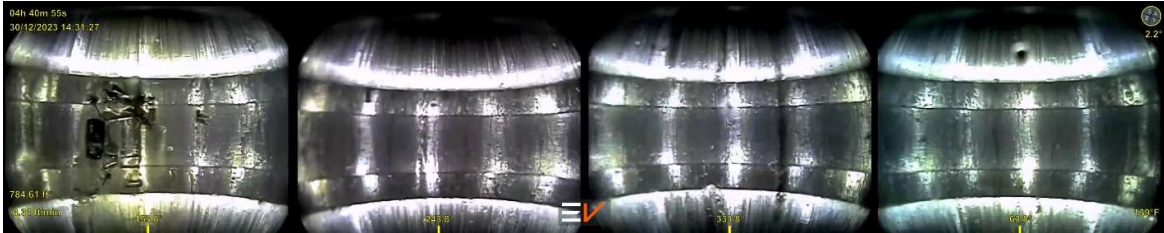
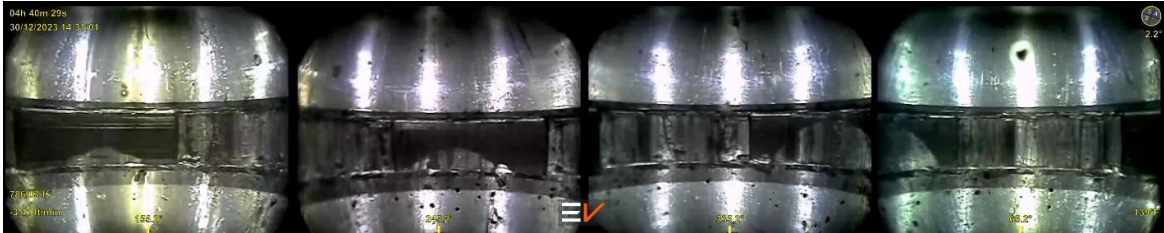
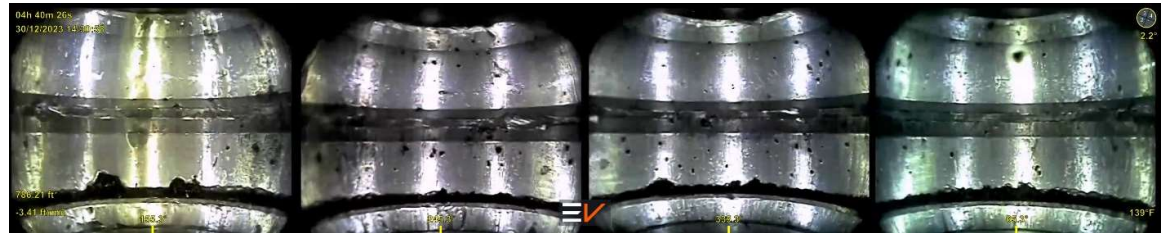
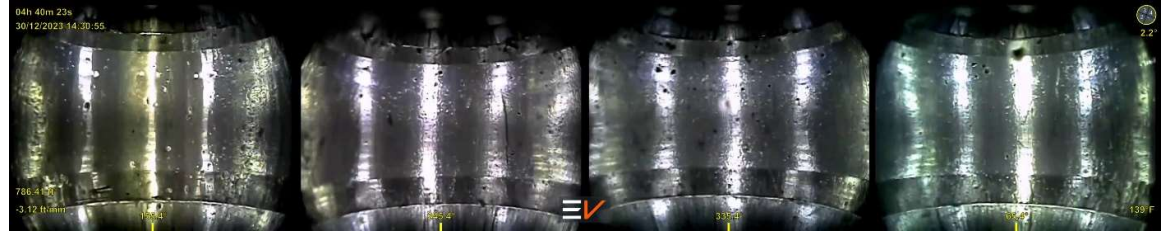
DV at 783ft

Video footage shows that there is no obstruction from the EGF Flapper that suspected to be in partially close condition.

The deepest depth of the camera survey is 787 ft (DV). No anomaly was found during log down to 787 ft.
